PROJECT NO.: 216063

TENTATIVE MAP

GRADING PLAN
2 OF 5

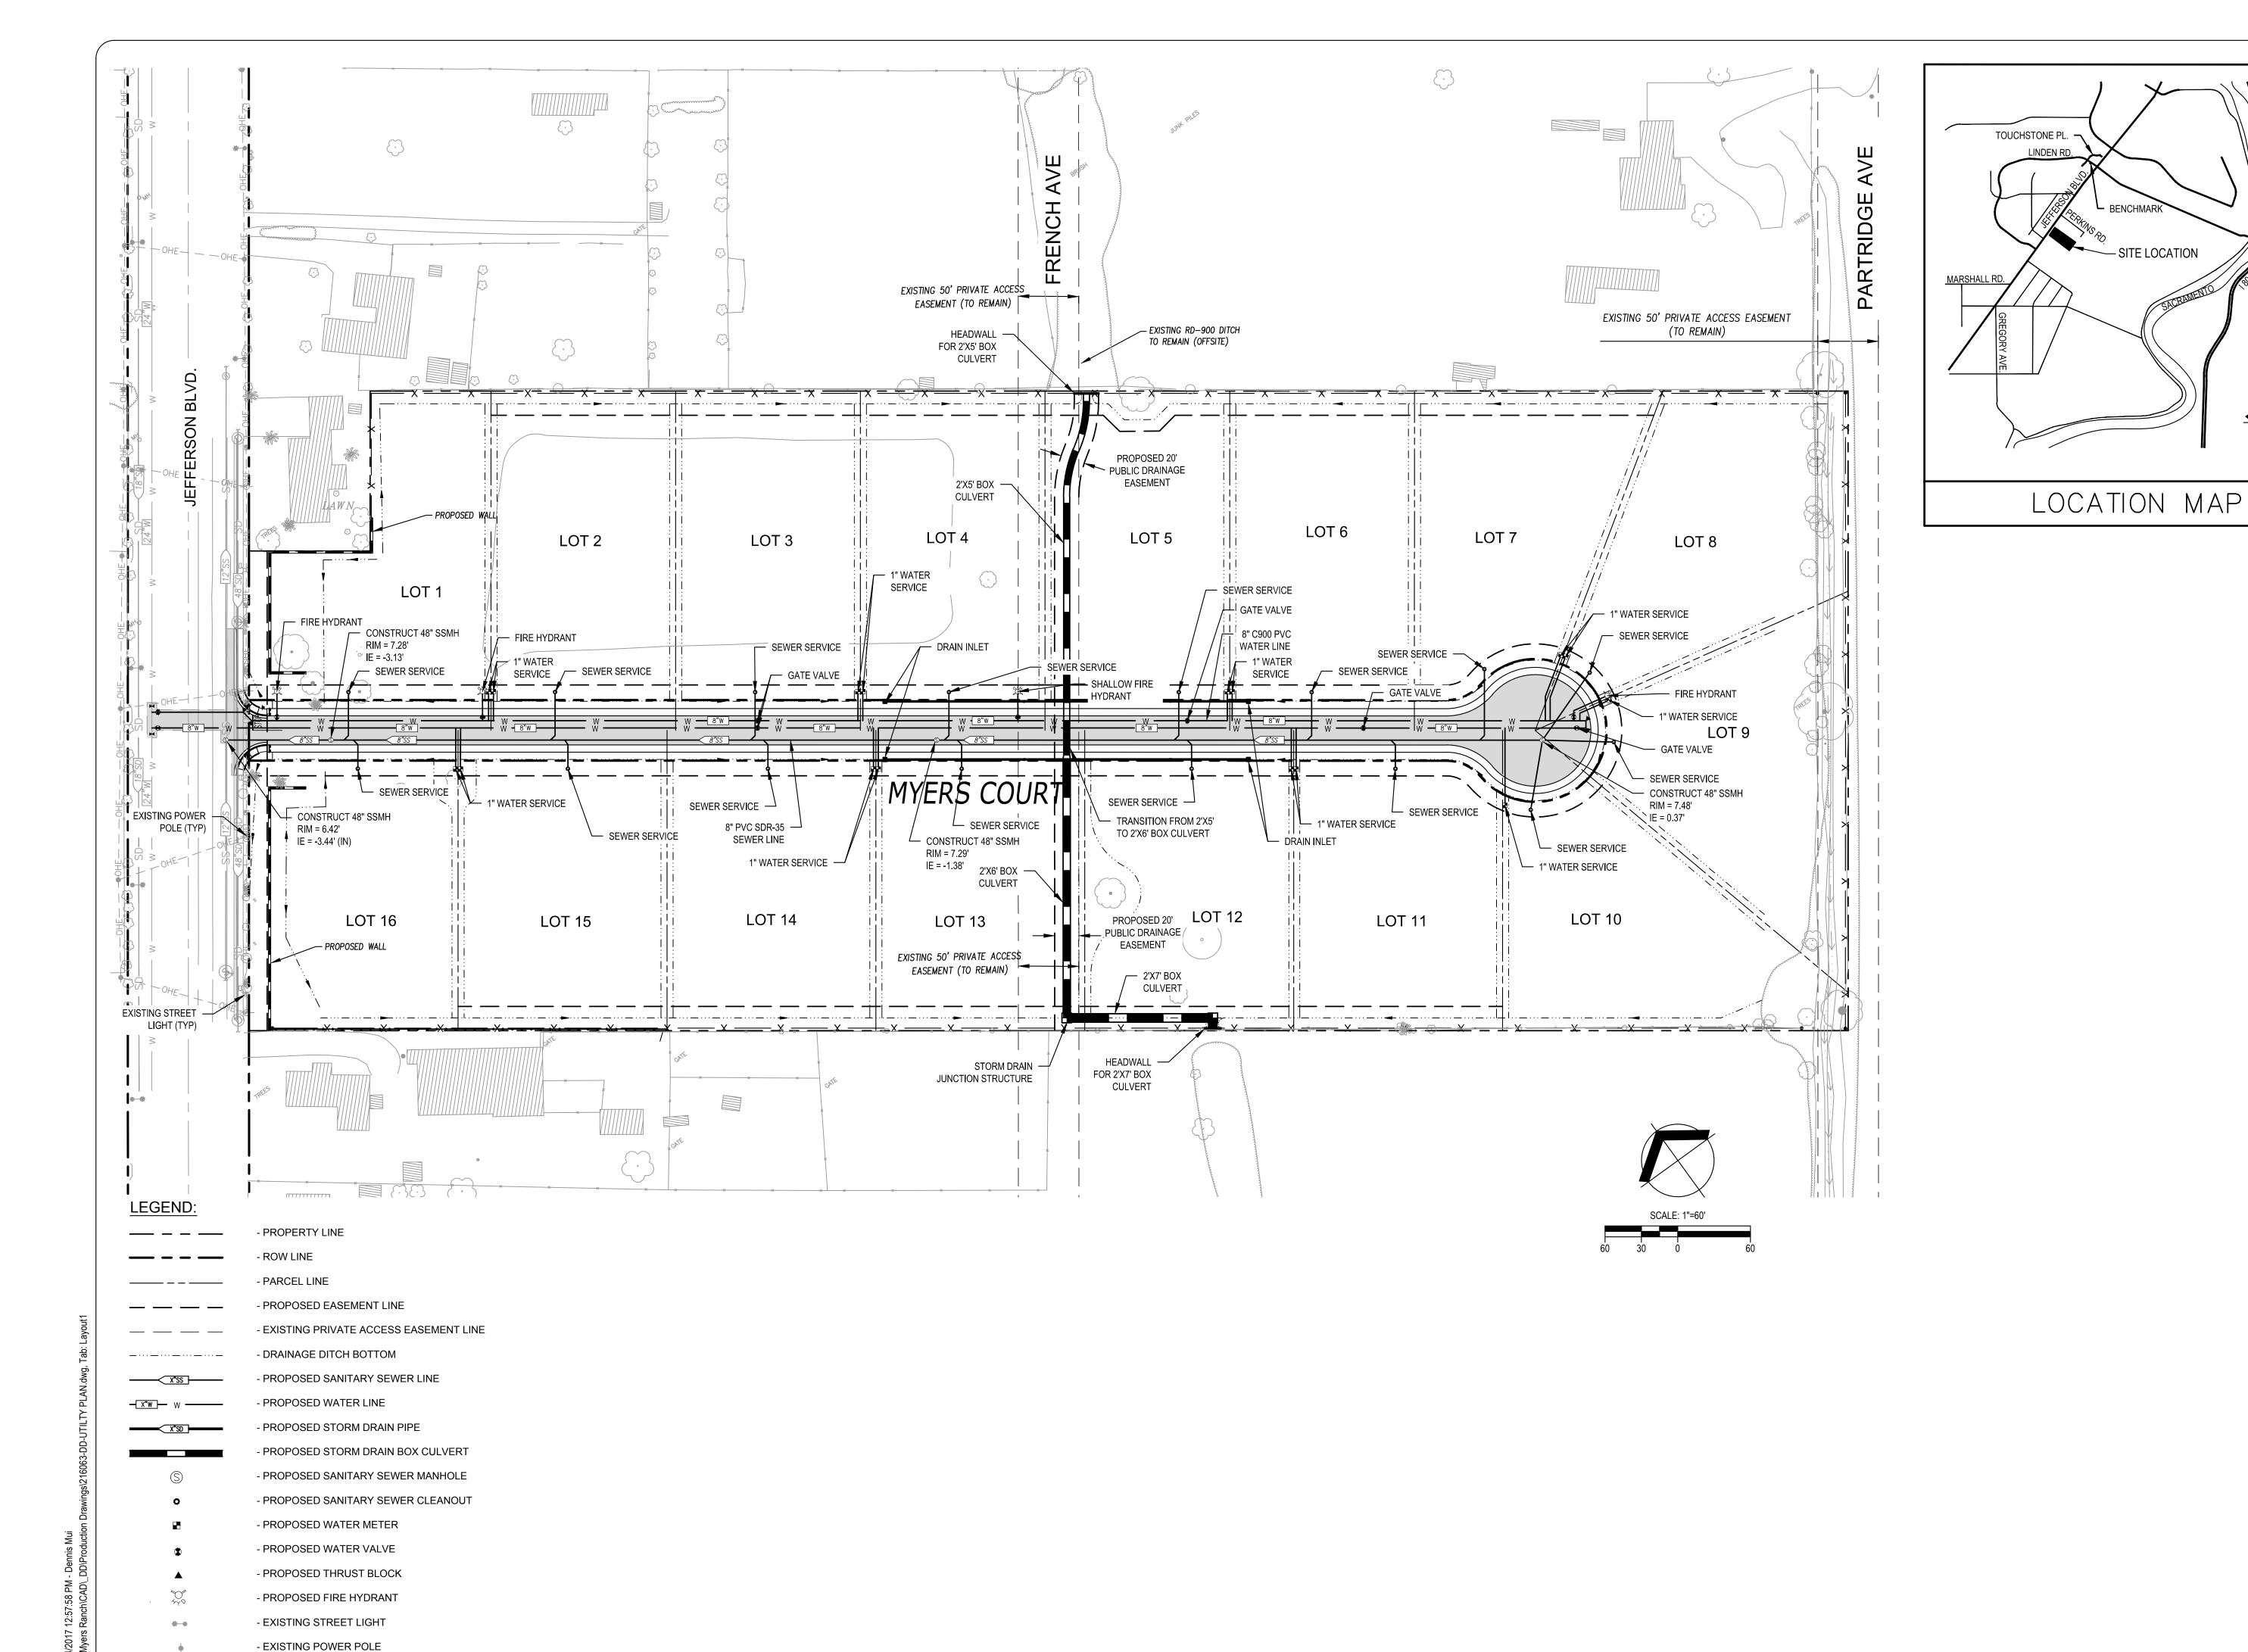
DATE: DESIGNED BY: DRAWN BY: CHECKED BY: UTILITY PLAN 3 OF 5

- PROPOSED STORM DRAIN MANHOLE

- PROPOSED DRAIN INLET
